Investigation Tactics for Prevention of Floating Roof Rim Seal Failures

Adam Vance, *General Manager at Mesa Engineered Tank Products*

VOLUME 30, ISSUE 2

MARCH | APRIL 2024

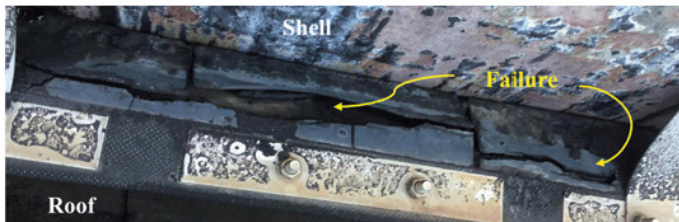
Figure 1. Chain hardening failure of polymer under bending forces.

Chain hardening causes the polymer to stiffen and become brittle. Light, ozone, and/or heat cause free radicals to interact with the polymer to create crosslinks between the polymer chains. Joining the polymer chains together reduces the flexibility and makes the polymer increasingly stiff and brittle. When wedge wipers are subjected to consistent and often cyclic bending forces, stiffening can result in brittle failure that appears perpendicular to the direction of stress. In this case, it appears parallel to the tank shell (**Figure 1**).

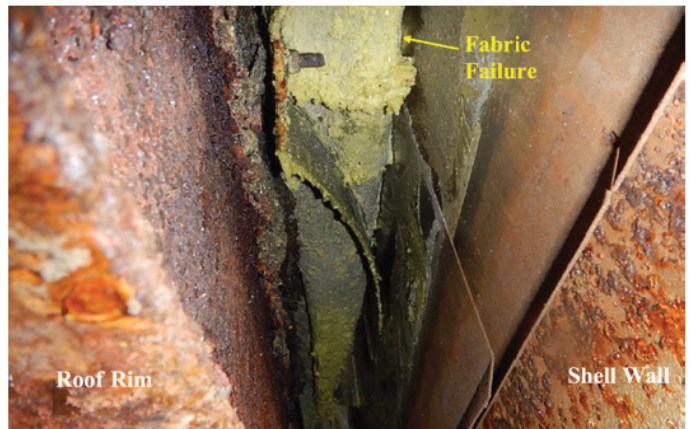
It should also be noted that even chemically inert materials can be attacked chemically, if there are other non-inert materials used in the construction of the fabric. An example of this is Teflon fabric with a fiberglass scrim. The fiberglass is used to provide resistance to tearing and provide strength to the Teflon film, which has very little structural strength. In certain environments, chemicals can interact with the fiberglass and cause stiffening and brittleness. This stiffening compromises the flexibility of the fabric and can lead to brittle failure of the emissions control fabric. Hydrogen Sulfide (H_2S) is a common compound found in stored fluids in the aboveground floating roof storage market. Extremely high concentrations of this compound can adversely affect inert Teflon fabric, particularly if it contains a fiberglass or another form of scrim, as the fiberglass will react with the H_2S . This presents as a brittle failure in the fabric (**Figures 2 and 3**).

Figure 2. Hydrogen Sulfide (H_2S) buildup on chemically inert Teflon emissions control fabric with fiberglass scrim.

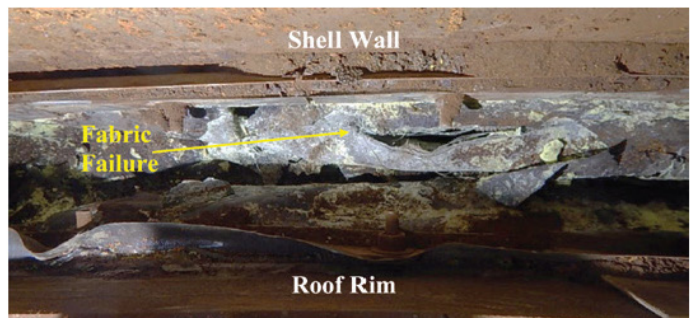
Figure 3. Hydrogen Sulfide (H_2S) causing brittle failure to Teflon fabric with fiberglass scrim.

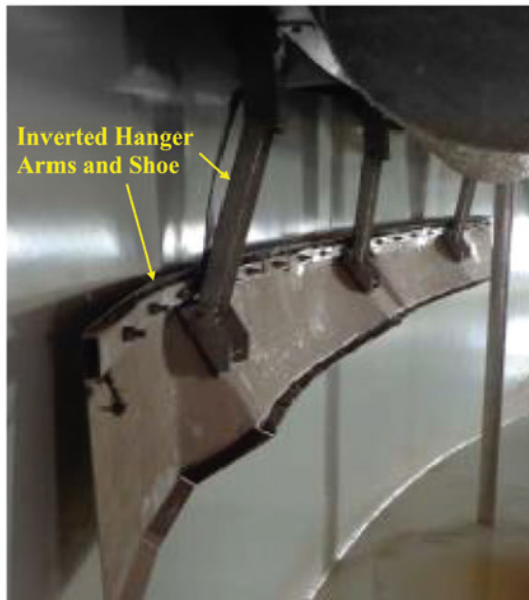
Figure 4. Overextension of mechanical shoe pivot linkage results in primary seal inversion.

linkage may reach a limit where further extension becomes infeasible. When the linkage is overextended, it allows the pivots and arms to flip, causing an inversion. This results in the primary shoe plates extending below the floating roof, rendering the primary seal useless. Typically, the mechanical shoe seal fabric can offer some protection against inversion by limiting extension movement. However, it is possible, especially with primary rim seal pivot systems utilizing a pivot that is centralized in the rim space and those with undersized arms, to invert (**Figure 4**).

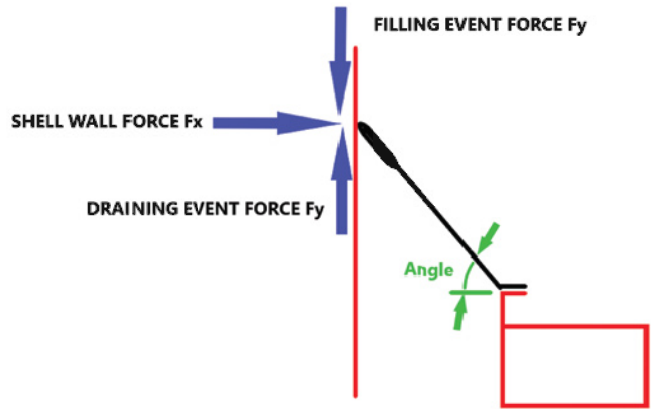
Figure 5. Demonstration of forces applied to metal secondary compression plate seals.

As the rim space grows, the steel secondary compression plate will extend to equilibrium, where the compression plate was originally pre-formed at the acute bend angle. As the pre-formed angle approaches, the compression plates provide less force, which results in less supporting force from the shell wall to the secondary seal. If the rim space extends beyond the maximum tolerance of the seal, this lack of force and contact can result in the secondary seal losing enough support force to remain in a vertical condition. The polymer extrusion wiper tip can create enough friction to overcome the vertical support force of the compression plate, which causes a rollover of the secondary seal. This can be seen as the compression plate being formed into a half circle, with the extrusion now extending downward towards the product

stored. This failure can propagate and typically requires complete removal and replacement of the affected areas (Figure 5).

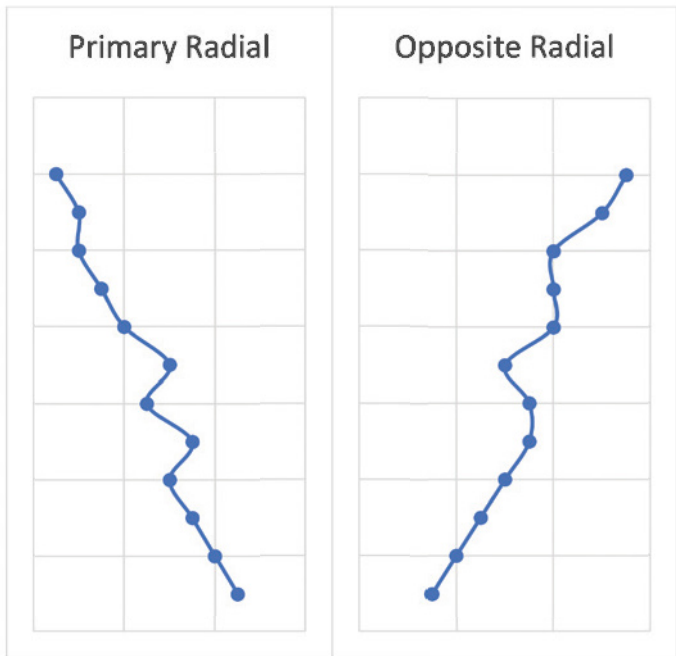
Figure 6. Shell wall verticality divergence across opposite radials.

Verticality measurements, along with rim spaces, can highlight challenges and areas of concern for rim seals. Diverging shell walls will put stress on rim seals. As the envelope widens across opposite points, the compression force on the rim seal lessens equally. This lower compression force can allow additional movement of the rim seal and puts the rim seal at risk of exceeding the top-end tolerance at either radial (Figure 6).

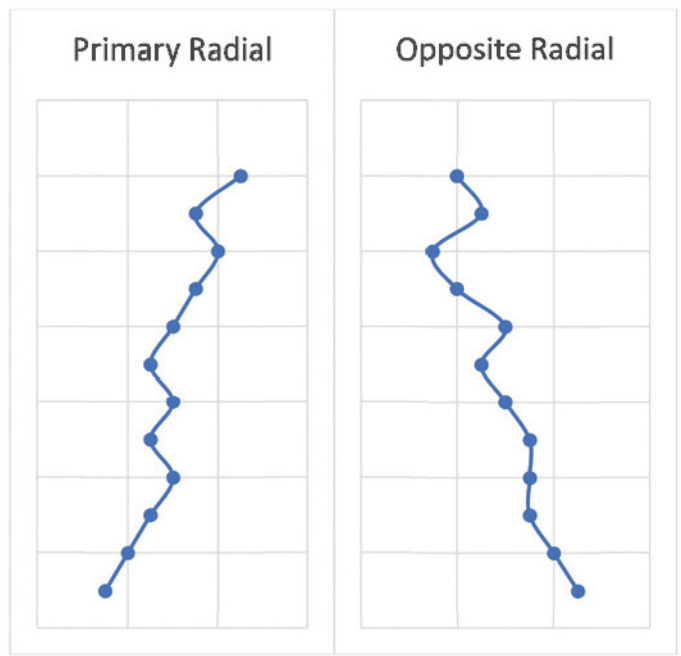
Figure 7. Shell wall verticality convergence across opposite radials.

Converging shell walls also poses a challenge for rim seal navigation. As shell walls converge, care must be taken to ensure the rim spaces will allow passage of the rim seal through the narrowing rim space. If convergence is severe, the collapsed rim seal may not be able to pass through the space and cause failures, as indicated in the previous section (Figure 7).

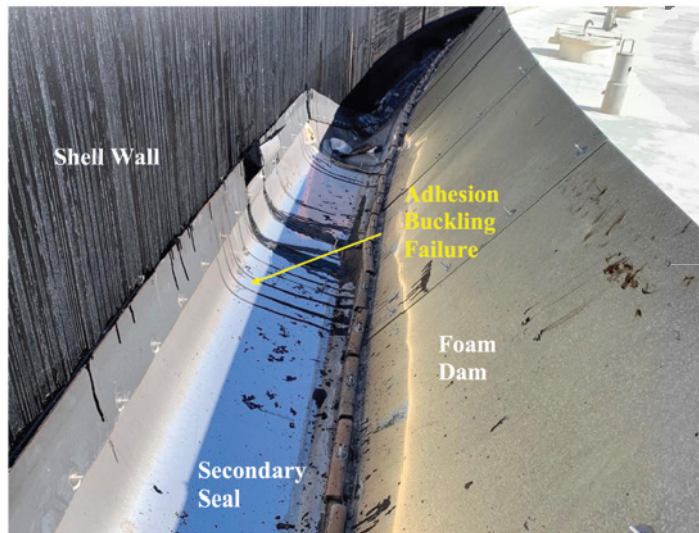
Figure 8. Buckling of metallic secondary seal compression plate due to polymer extrusion adhesion to shell wall.

It is also possible for the product being stored to physically interact with the rim seal. Some stored products, like certain crude oils, can exhibit properties that make the product viscous or tacky. This can impact both the primary and secondary rim seals, but in particular, it can be challenging for steel secondary seals with polymer extrusions. If conditions allow, a product that is tacky and clings to the shell wall can interact with the polymer extrusion and result in adhesion of the extrusion to the shell wall. If the polymer extrusion is partially or fully adhered to the shell wall, this can put extreme stress on the secondary seal steel compression plates. Especially concerning adhesion, a filling cycle following a period of static storage exerts vertical forces on the compression plate, which may lead to bending and subsequent failure of the secondary seal. As opposed to rollover with the extrusion pointing downward towards the rim, the resulting bending causes an upward arc of the secondary seal due to the buckling of the metallic compression plate (**Figure 8**).

Temperature, extended rim spaces, and the prolonged static state of the floating roof can all add to the risk of adhesion with certain stored products. Adhesion requires consultation with the seal manufacturer to understand the product stored and conditions promoting this phenomenon in order to mitigate future failures. In the case of adhesion, specific steel secondary seals should be utilized that are specifically designed to counteract adhesion breakout forces. Seal manufacturers should be consulted when concern of adhesion exists.
